FIGURE 1.2. Kalama Hills from Kivandini, June—July (?) 1937. Map Sheet 162/2, GR 3104E, 98302N Brg. 145°. (Photo: KNA: R. O. Barnes, 1937, photo 1. Reproduced by permission of Kenya National Archives.)

FIGURE 1.3. Kalama Hills from Kivandini, September 1991. Map Sheet 162/2, GR 3104E, 98302 145°. (Photo: M. Mortimore)

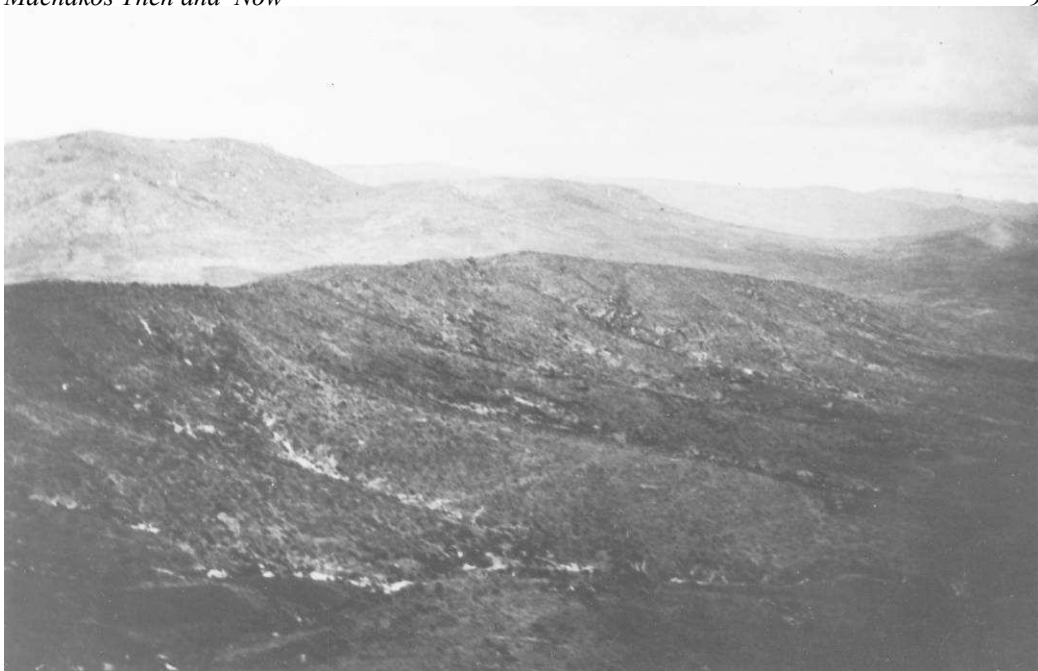
FIGURE 1.6 Kyamunyu, from Mumandu (Mbevo S.) hill, June—July (?) 1937. Map Sheet 162/2, GR 3096E, 98175N; Brg. 90°. Photo: KNA: R. O. Barnes, 1937, photo 7. Reproduced by permission of Kenya National Archives.)

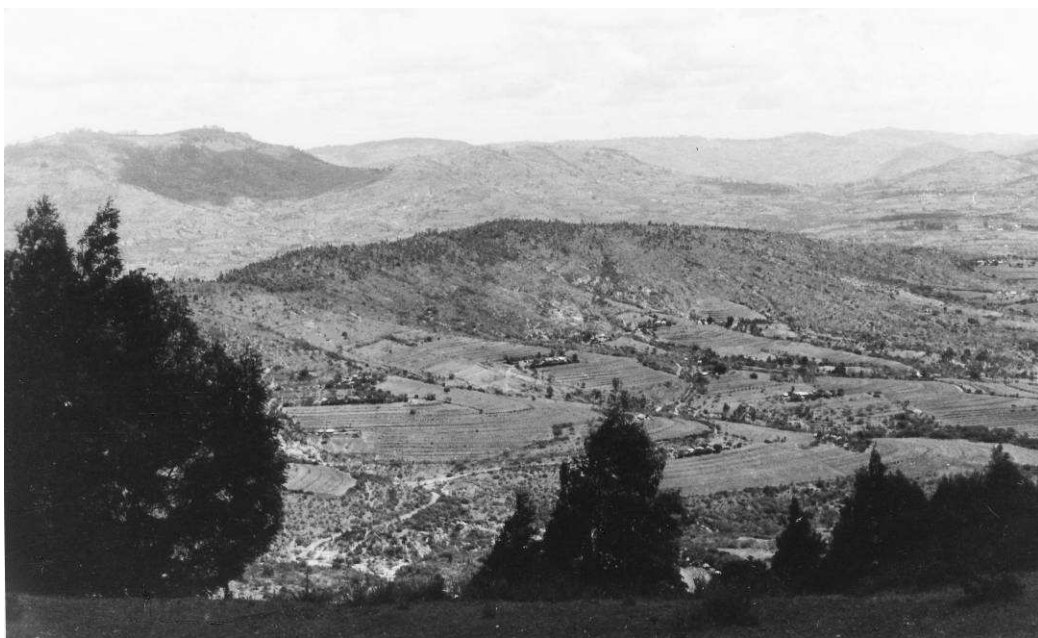
FIGURE 1.7 Kyamunyu, from Mumandu (Mbevo S.) hill, January 1991. Map Sheet 162/2, GR 3096E, 48175N; Brg. 90°. (Photo: M. Mortimore)

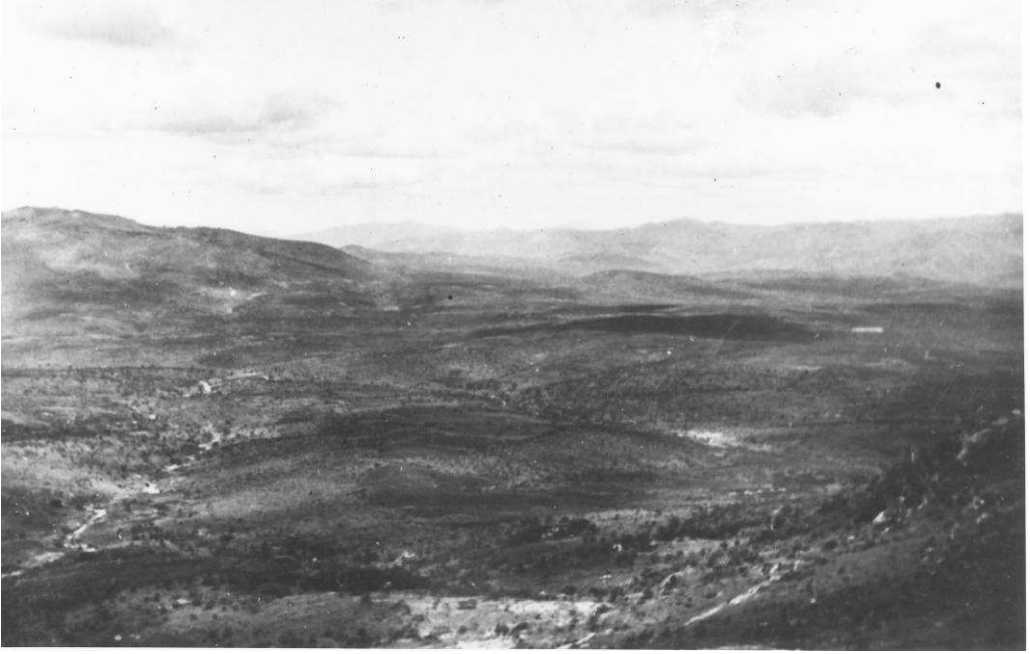
FIGURE 1.8. Plains of Iuni, from Mumandu (Mbevo S.) hill, June—July(?) 1937. Map Sheet 16/2, GR 3096E, 98175N; Brg. 140°. (Photo: KNA: R.O. Barnes, 1937, photo 22. Reproduced by permission of Kenya National Archives.)

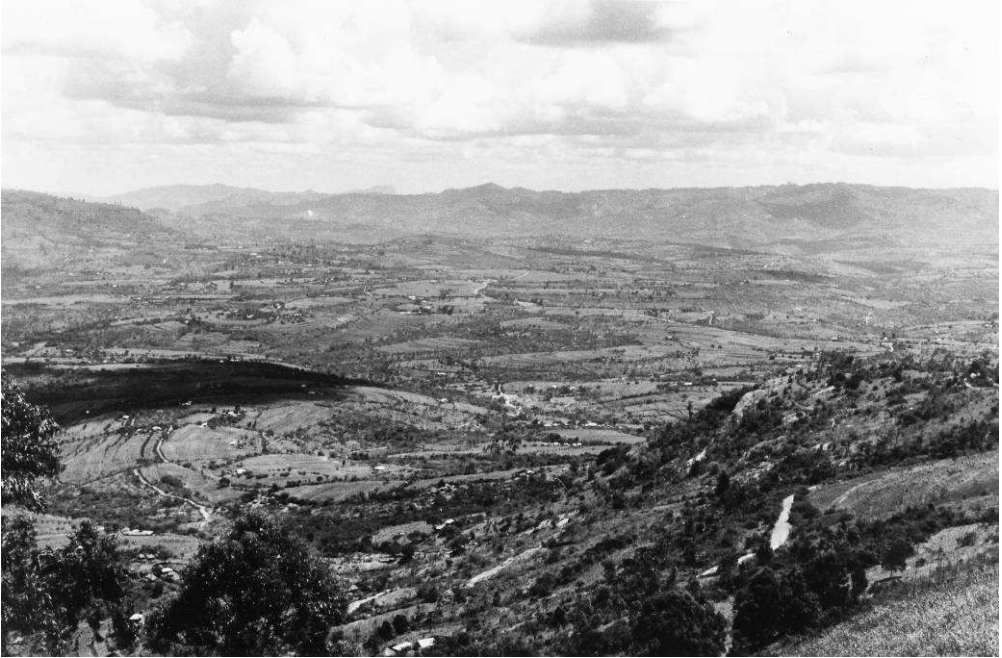
FIGURE 1.9. Plains of Iuni, from Mumandu (Mbevo S.) hill, January 1991. Map Sheet 16/2, GR 3096E, 98175N; Brg. 140°. (Photo: M. Mortimore)

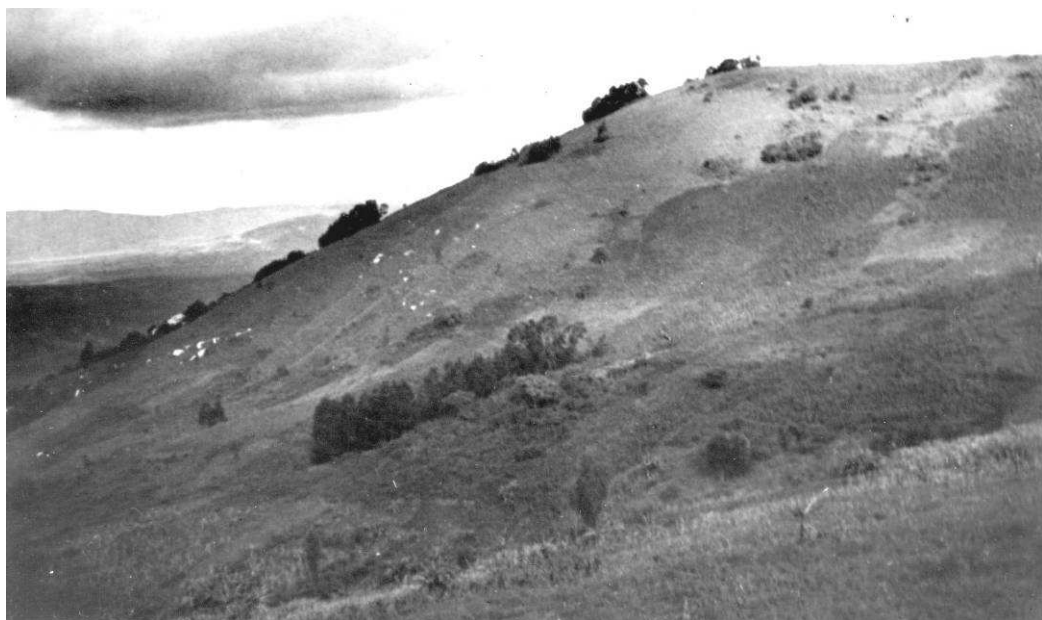
FIGURE 1.10. Kūima Kimwe Hill (NE slope), June—July(?) 1937. Map Sheet 162/2, GR 3085E, 98296N; Brg. 110°. (Photo: KNA: R. O. Barnes, 1937, photo 18. Reproduced by permission of Kenya National Archives.)

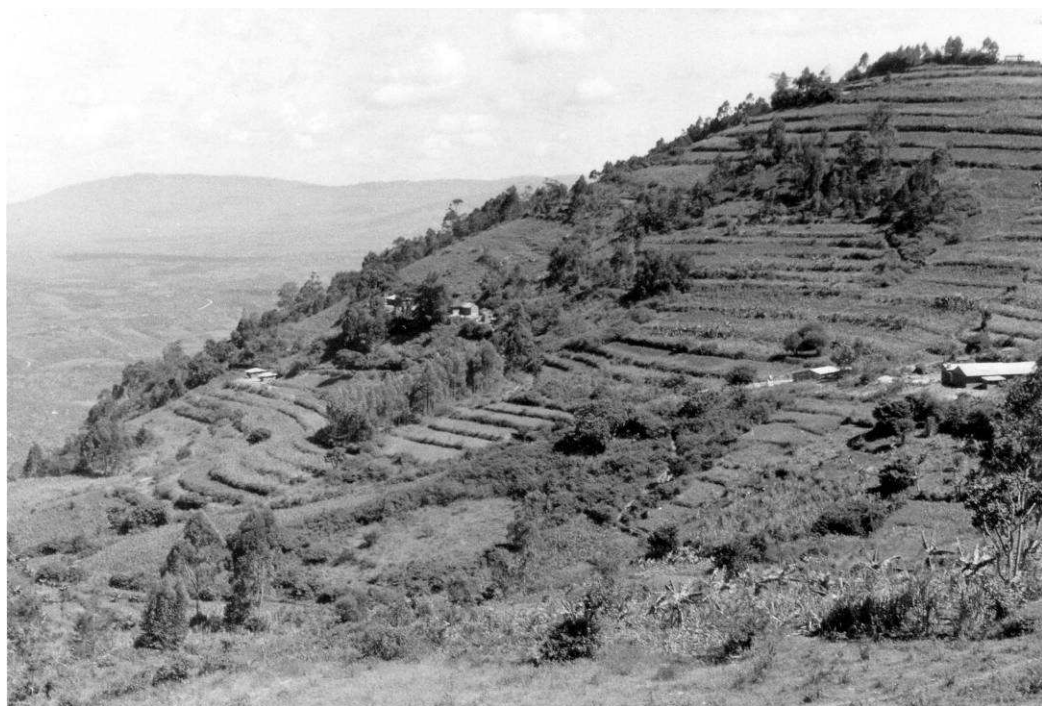
FIGURE 1.11. Kūima Kimwe Hill (NE slope), January 1991. Map Sheet 162/2, GR 3085E, 98296N; Brg. 110°. (Photo: M. Mortimore)

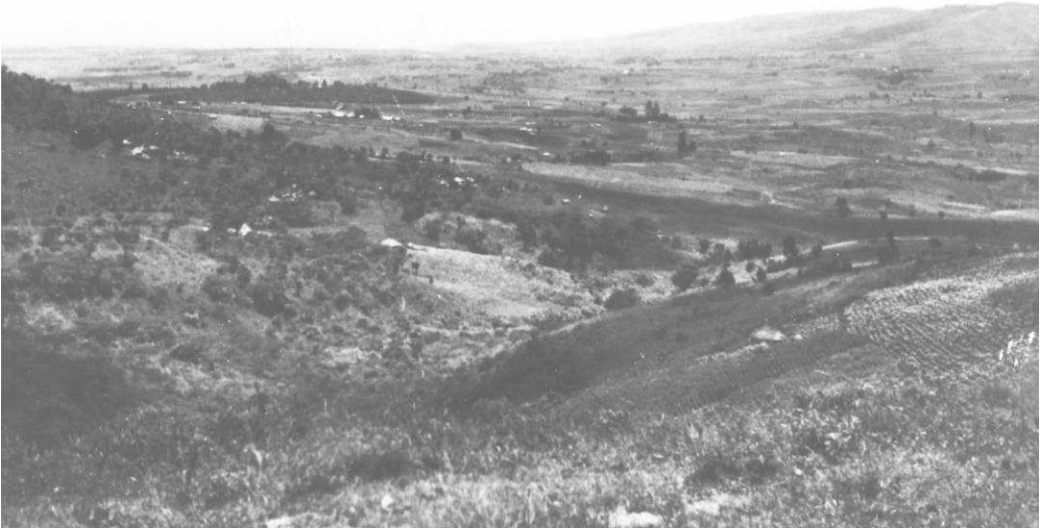
FIGURE 4.1. 'Looking north from below Muisuni trig point to Tula and the Matungulu slopes, possibly the finest stretch of agricultural land in Kenya, producing with Kangundo 5/6 of the maize and beans exported from the Ukamba reserve.' (KNA: R. O. Barnes, 1937, photo 21. Reproduced by permission of Kenya National Archives.)

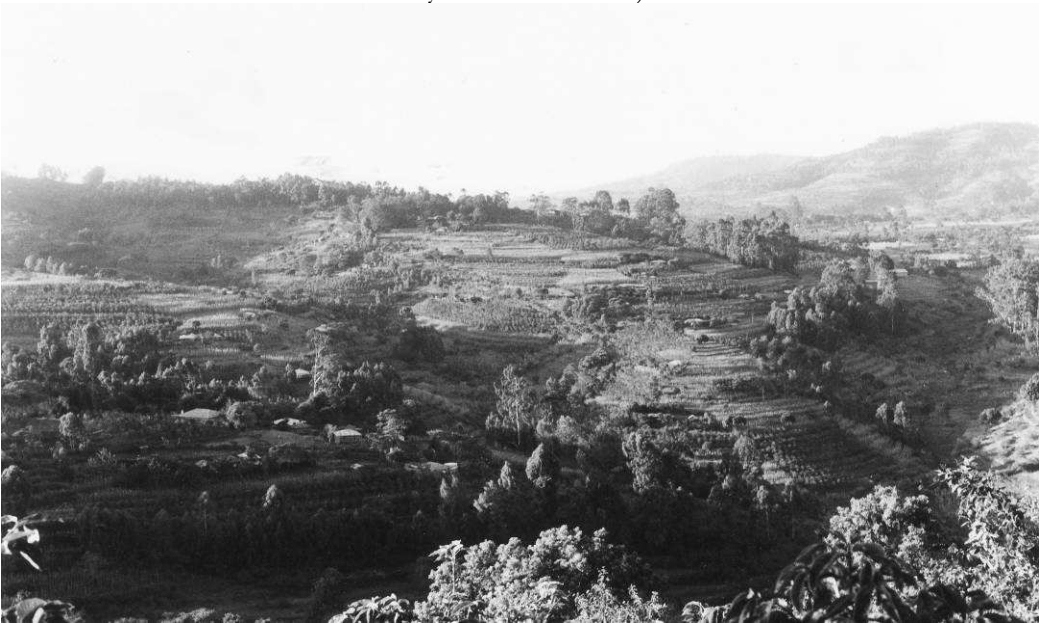
FIGURE 4.1., Cultivation of coffee and other crops on the terraced slopes of Muisuni in 1990, near the site of Barnes' photo 21 (his exact standpoint could not be identified). (Photo: M. Mortimore)

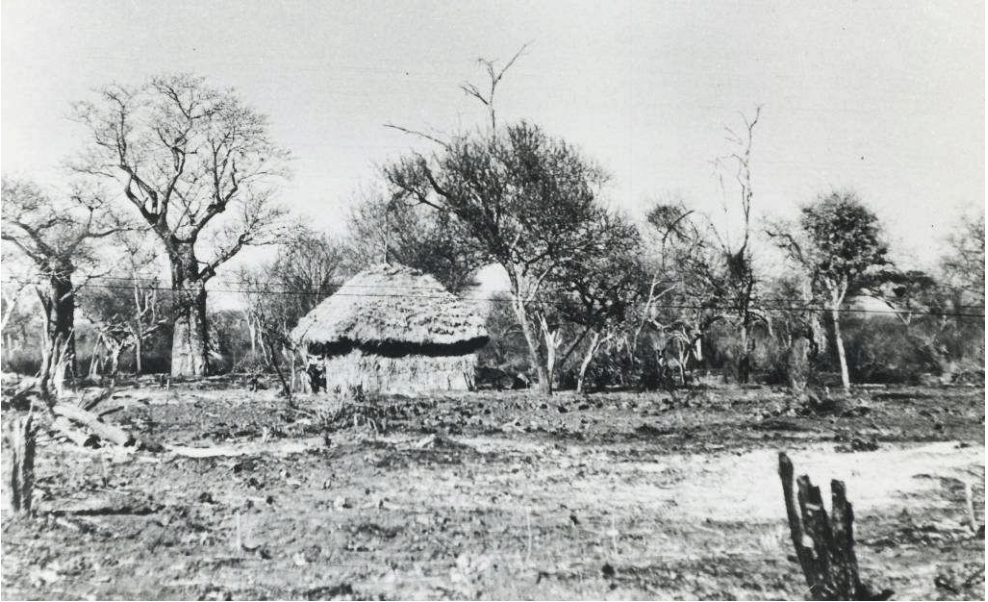
FIGURE 4.5. This new settler's home in Kikumbulyu in the 1960s illustrates both the hardships of new settlement and the methods of clearance and farming that were alarming conservationists at the time. (Photo: F. N. Owako, 1969. Reproduced with permission.)

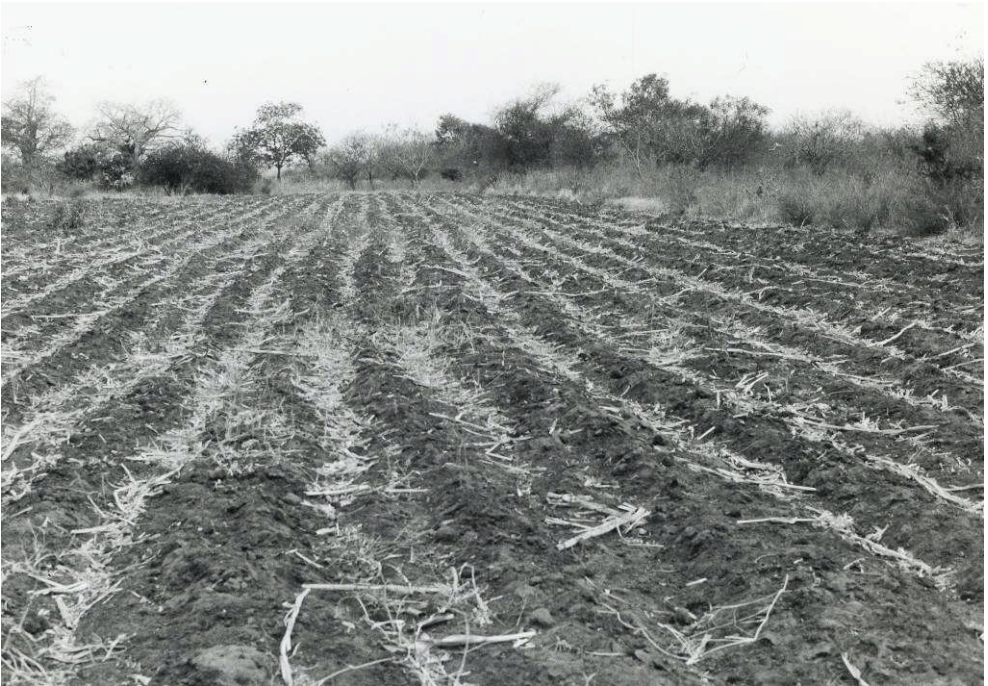
FIGURE 1.6 Many such sites are now examples of excellent cultivation and cropping systems to maximise rainfall infiltration, with useful trees conserved as farm boundaries. This farm is near Kambu, Ngwata Location, 1990. (Photo: D.B. Thomas. Reproduced with permission)

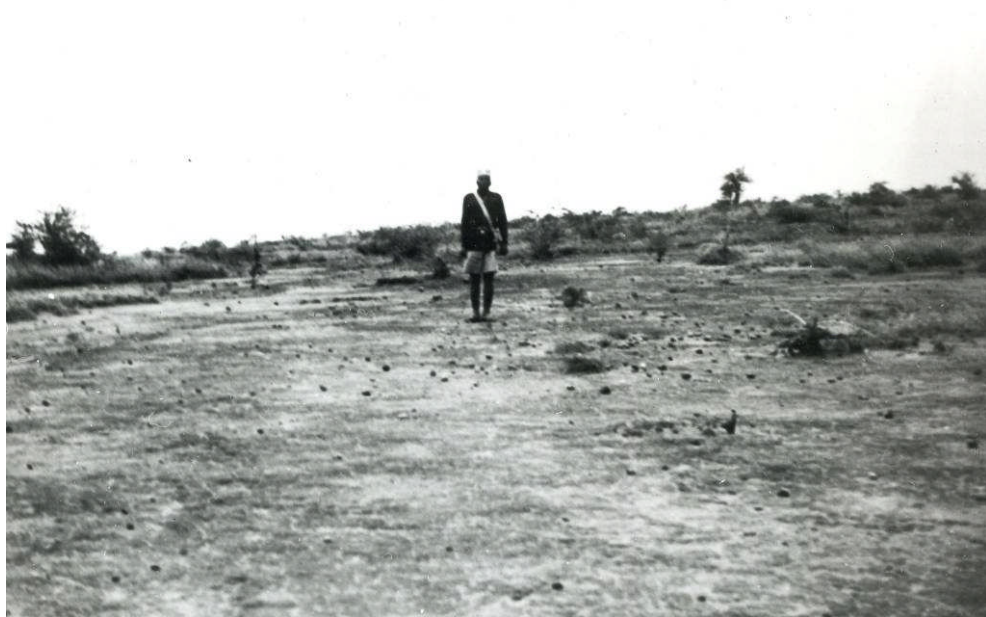
FIGURE 7.1. 'Typical eroded bare ground covering hundreds of square miles.' (KNA: R. O. Barnes, 1937: photo 14). Barnes notes that the area had been closed to grazing 'a short time' and moisture-holding silt was collecting against the grass at the edge, where seed could take hold. To hasten this process, he advocated artificial barriers to hold silt (Reproduced by permission of Kenya National Archives)

Erosion of grazing land in Machakos District has been noted since the early years of the century and has been one of the hardest problems to deal with (Pole-Evans, 1939; Pereira and Beckley, 1952; Peberdy, 1958). Early incidences of erosion were attributed to increased livestock numbers as a result of improved veterinary services, protection from theft, and reduced grazing area. The natural vegetation of the District is characterised by tufted and patchy perennial grasses which, when grazed down, expose the intermittent bare soil to erosion and compaction by rain drops. Such bare patches can be seen clearly in Figure 1.2. Erosion removes the humus in the topsoil, and compaction impedes the infiltration of rainwater and the germination or growth of grasses and herbs (KNA: Cowley, 1947/18). Intensified grazing of the better pastures during periods of drought would have worsened the problem, and at such times, the activities of termites became more noticeable than usual. Pole-Evans (1939) noted that 'they were attacking living thorn trees in the absence of any other material'. Areas of bare or nearly bare ground expanded and coalesced in the manner of a skin disease. These bare lands with capped soils became known as *mangalata*, or 'bad lands', as shown in Figure 7.1

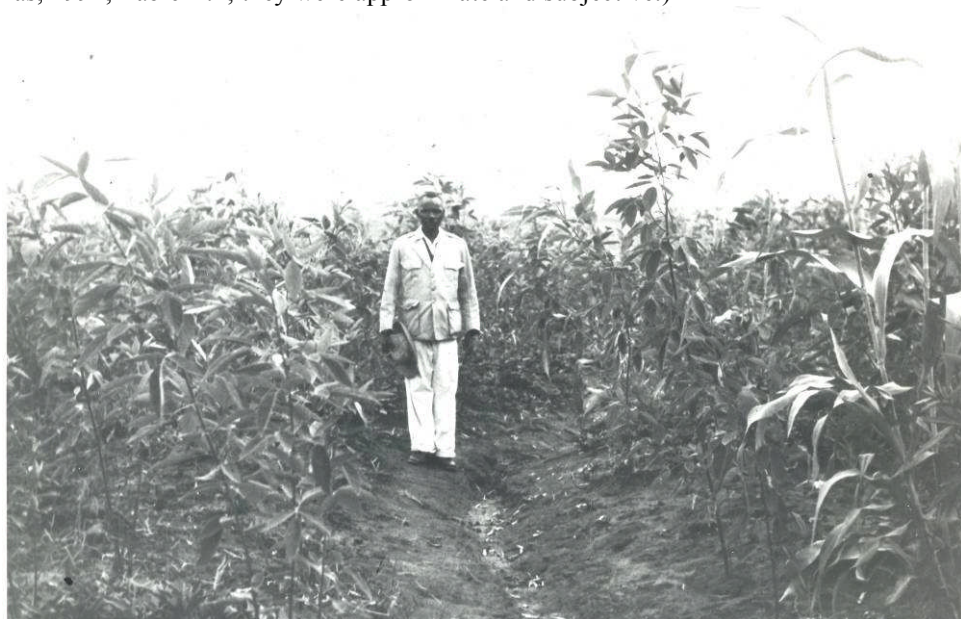
FIGURE 7.2. 'Showing erosion in the rich Matungulu area, starting from paths and boundary trenches' (KNA: R. O. Barnes, 1937: photo 25). This illustrates why observers were worried by cultivation on the hills. See also Figure 1.4, where Barnes notes numerous small gulleys starting out of 'abandoned or closed native shambas' above the road (Reproduced by permission of Kenya National Archives)

The reason they give for these gulleys is that the cover is now off the hills above but they do not realise that the enormously increased run-off is also due to the drop in humus content of these huge expanses of cultivation. They do attribute small washouts and gulleys to their own practice of marking out their plots with drains, which catch and concentrate the water (shown in Figure 7.2).

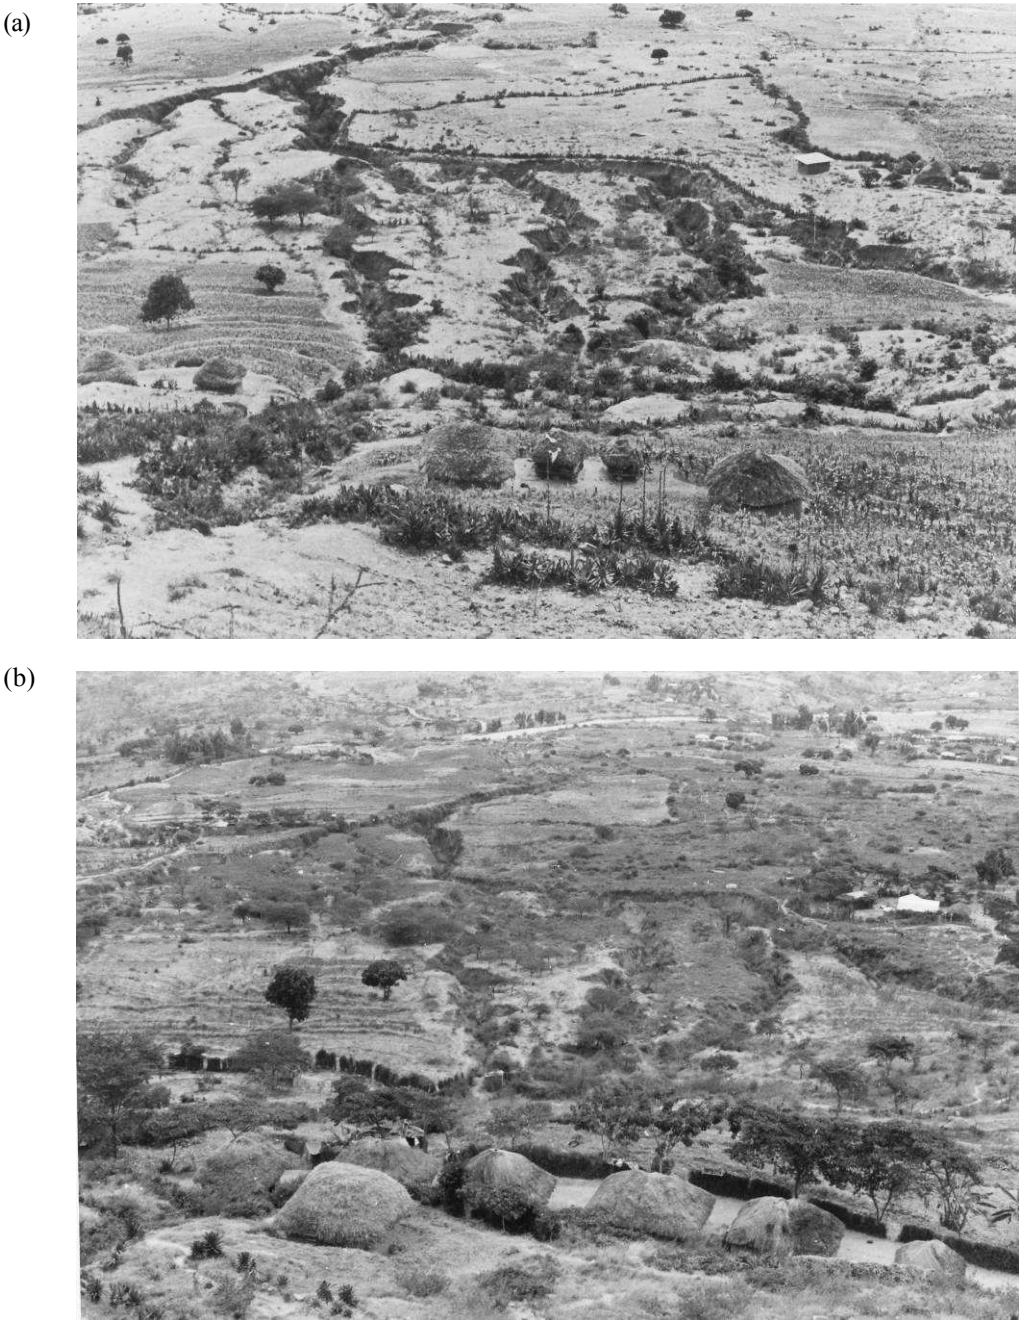
FIGURE 7.3. Gullies in Kalama photographed in (a) 1974 (Thomas, 1974) and (b) 1990. The centre gully, which started forming circa 1950, is about 12 m deep. In 1974 it was still widening. In 1990 it was relatively stable. Note the increase in trees. A woman farmer interviewed had planted trees near the gully edge to try to prevent it expanding. (Photos: D. B. Thomas. Reproduced with permission

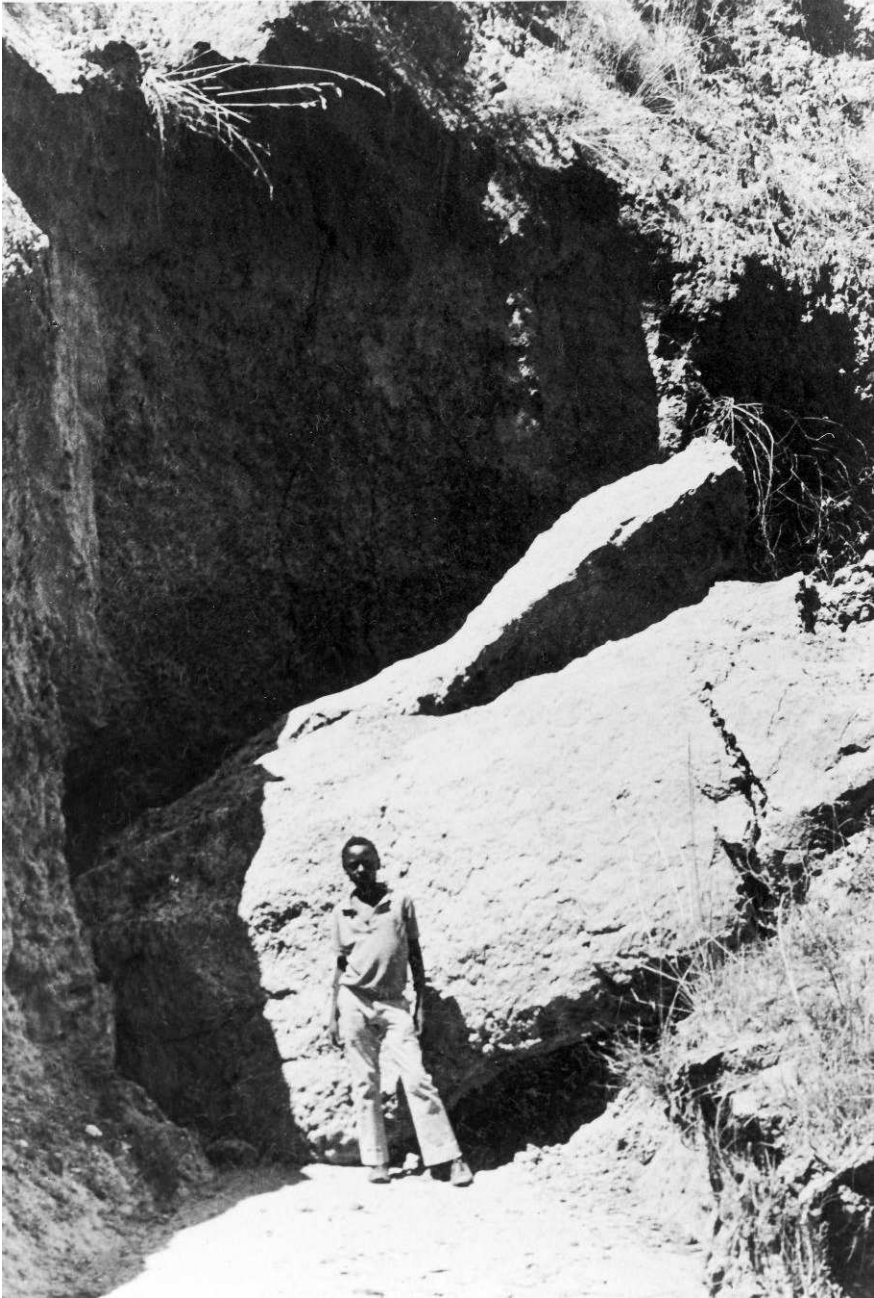
FIGURE 7.4. (a) Bottom of the central gully in Figure 7.3, in 1972, when major slumping was still occurring (Thomas, 1974). (b) In [990, vegetation was taking hold at the same spot. (Photos: D. B. Thomas. Reproduced with permission.)

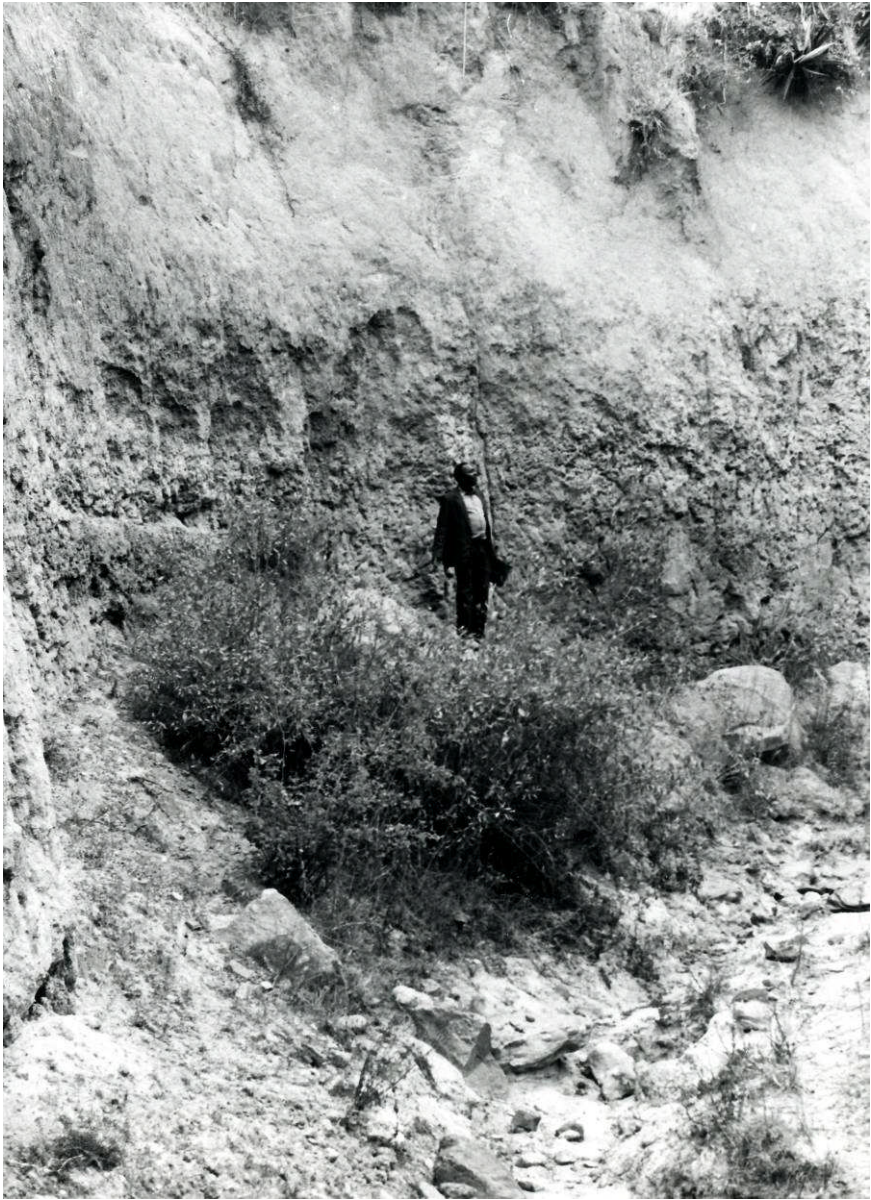
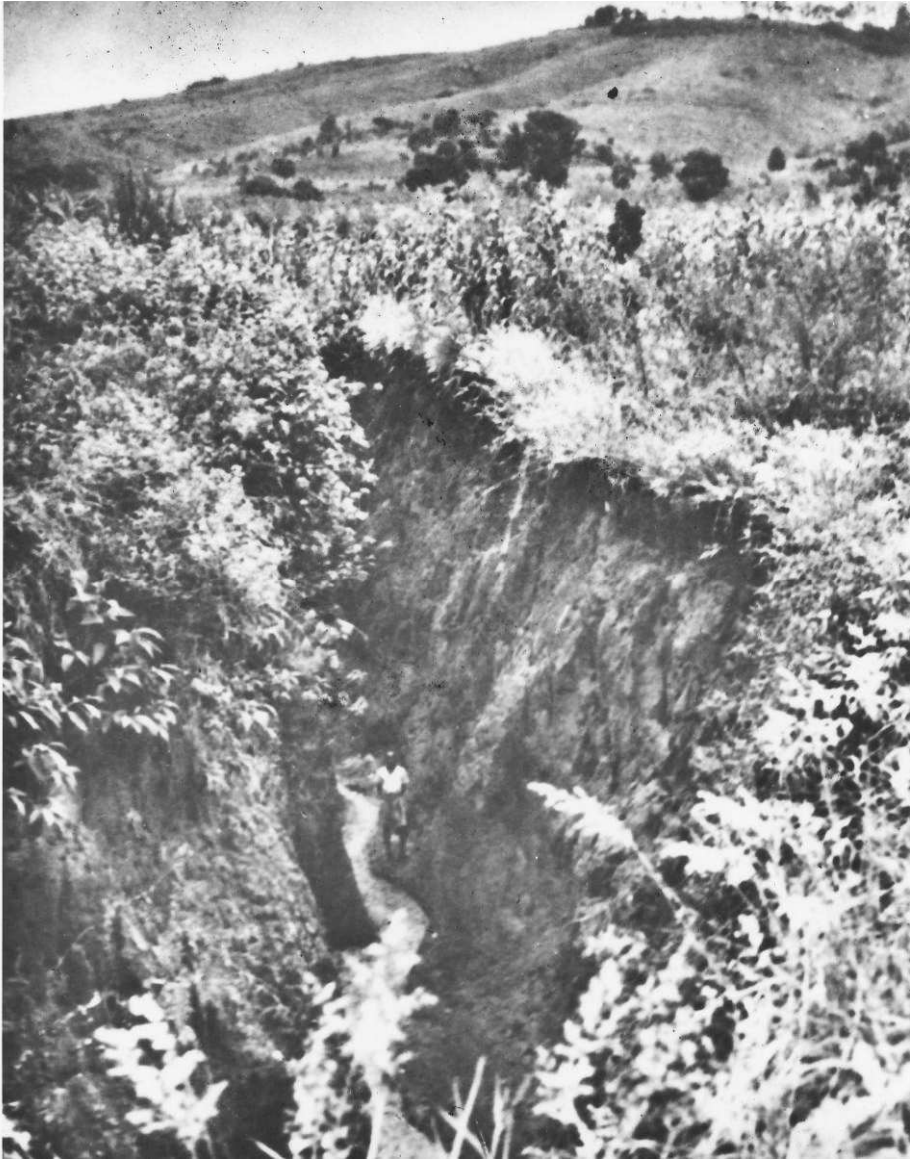
FIGURE 7.5. (a) Gully in Matungulu in 1937, said to have expanded from a small water course that could be stepped over 1.0 years previously, due to run-off from the cultivated fields above (KNA: Barnes, 1937, photo 29. Reproduced by permission of Kenya National Archives)

7.2 and 7.5(a)),

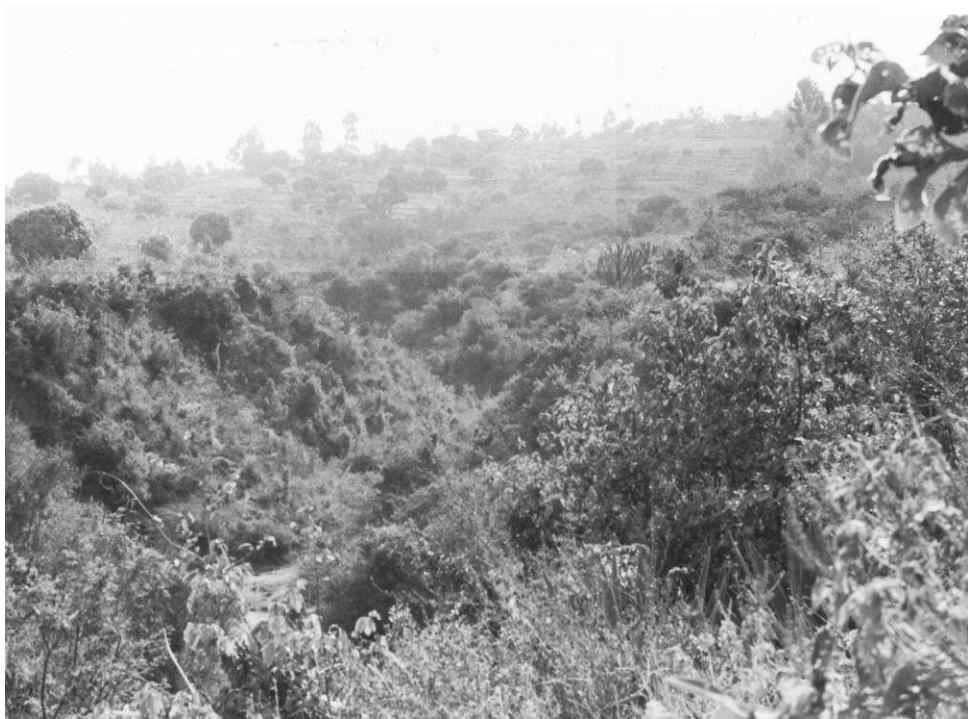
FIGURE 7.5 (cont.) (b) The same gully in 1990, wider, but largely revegetated. (Photo: D. B. Thomas.) The site is near the spot photographed by Barnes, but the exact location of this cannot be identified. Note terracing and additional tree cover on the hill above (Reproduced with permission)

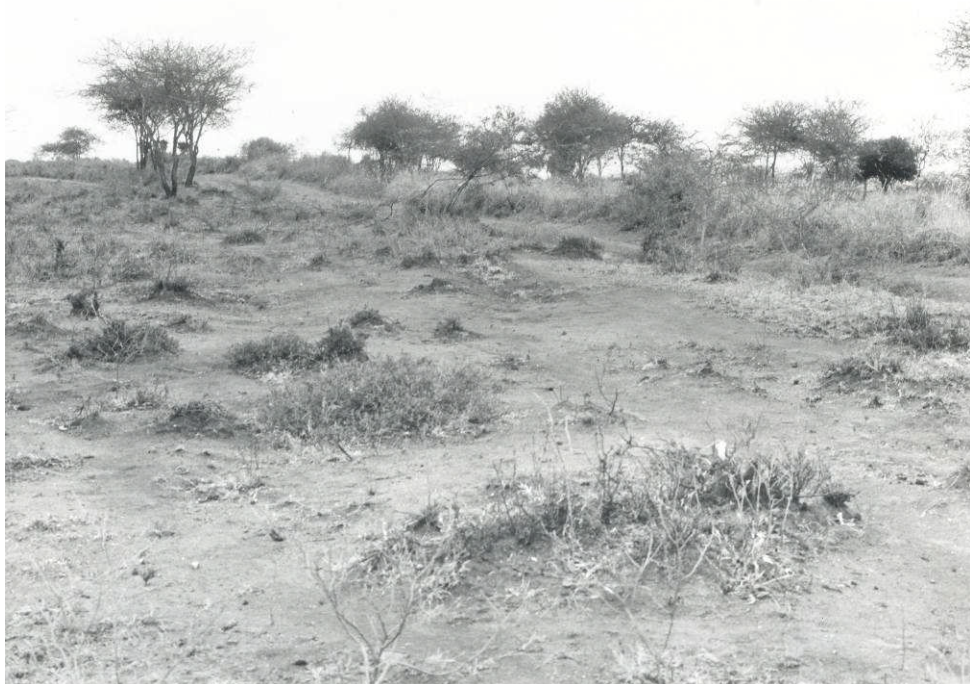
FIGURE 7.8. Denuded grazing land in 1990 near Mavindini, Makueni Location, in the left foreground, separated from excellent cover in the right background which is protected by a hedge of thorn branches, demonstrating the effects of different individual management. (Photo: D. B. Thomas. Reproduced with permission.)

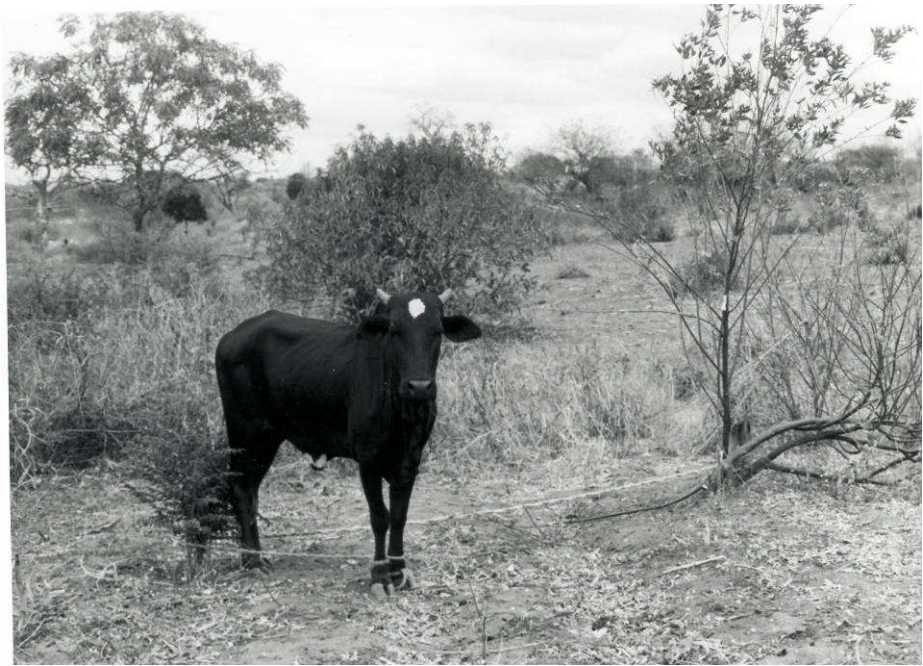
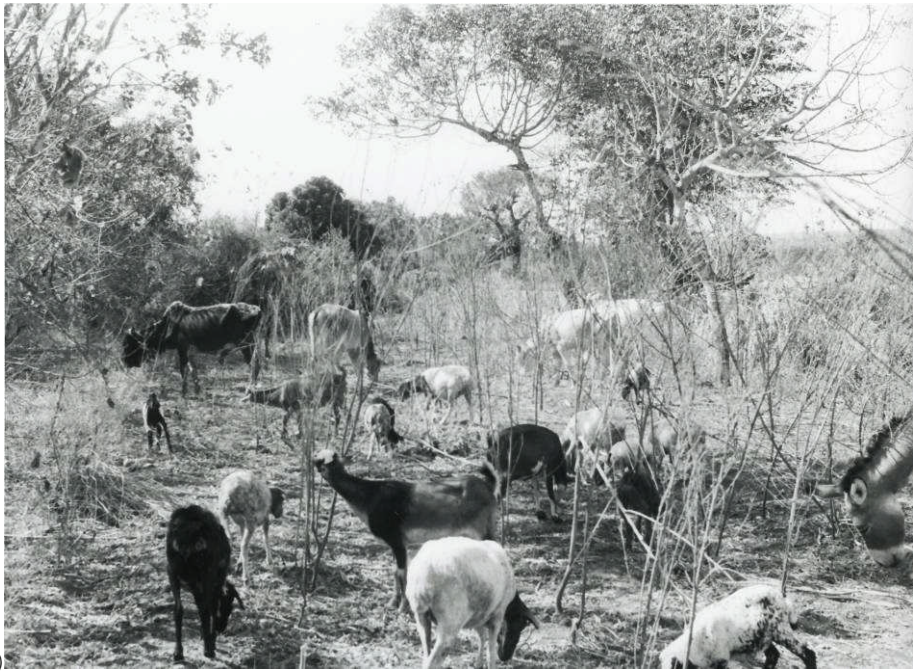
FIGURE 10.1. (a) A tethered cow in a recently settled area, Kambu, Ngwata Location, showing grazing management. (b) Livestock feeding on pigeon pea residues, in the same Location. (Photos: D. B. Thomas. Reproduced with permission.)

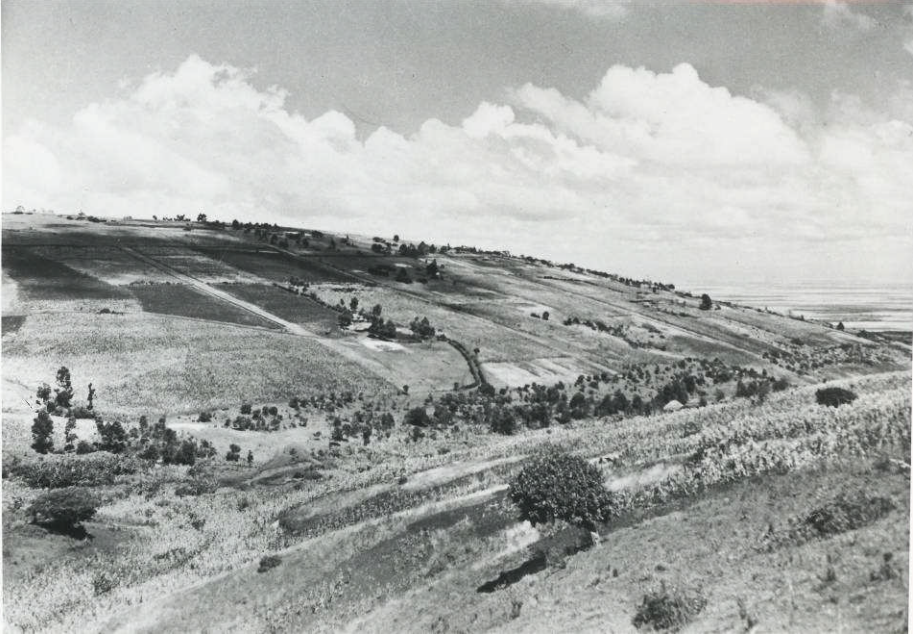
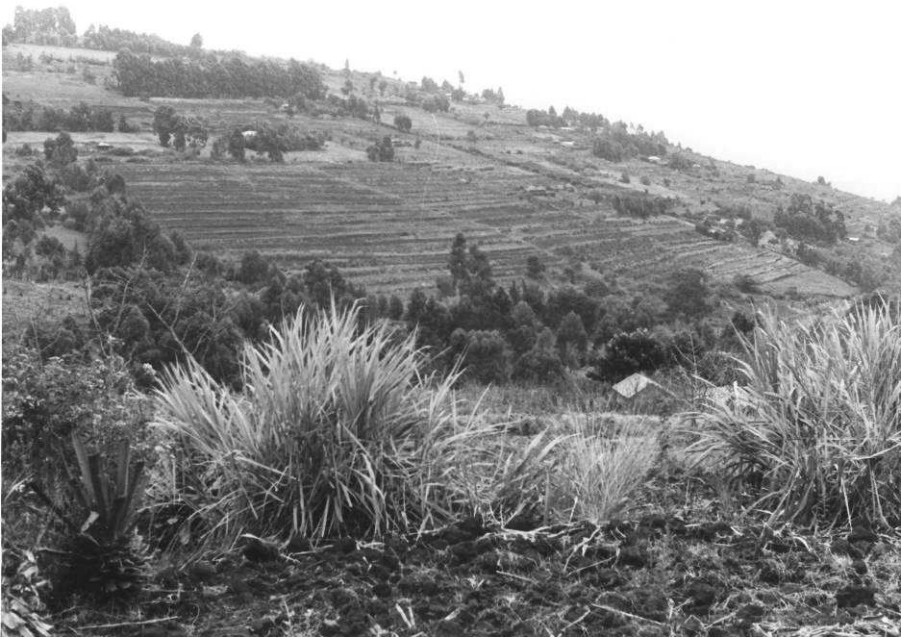
FIGURE 11.1. Matungulu conservation area, (a) 1952 and (b) 1990. The original 'contour ditches' which 'spill into grassed run-offs' have been converted to benches (Photos: Kenya, ALUS, 1953, Crown Copyright, Reproduced with permission of the Central Office of Information, and D. B. Thomas)

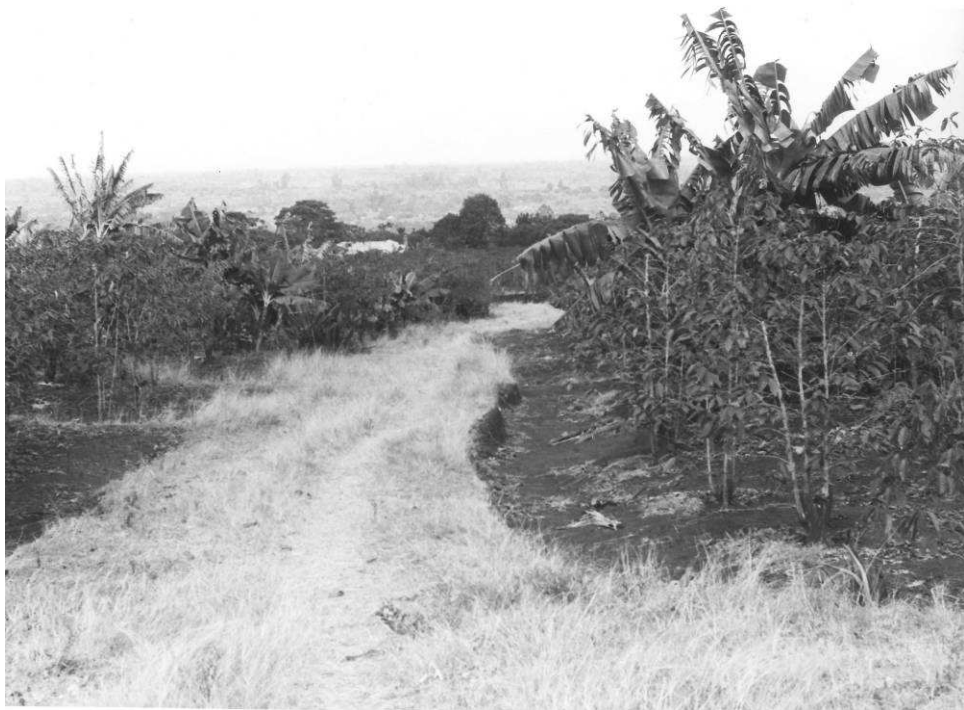
FIGURE 11.2, One of the original waterways in Matungulu, as seen in 1990. (Photo; D. B. Thomas. Reproduced with permission)

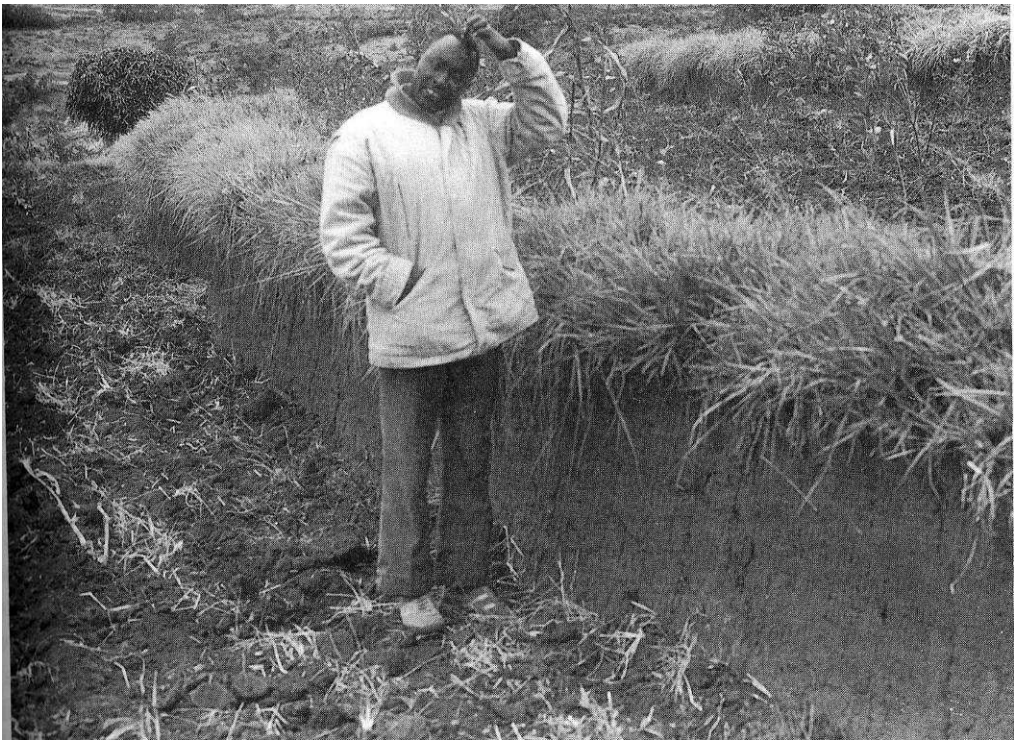
FIGURE 11.3. Pastor Mutua and his farm, 1990, on land reclaimed from *mangalata* in the 1950s. (Photo: D. B. Thomas. Reproduced with permission)

In the period following the Swynnerton Plan, 1954-1962, there were far more agricultural officers and even stricter enforcement of closed grazing areas with cattle confined to roofed sheds. Today these lands have become private farms, part grazed, part cultivated and terraced (see Figure 11.3 and interviews later in this chapter). A 1981 survey in AEZ 4 found that 30%

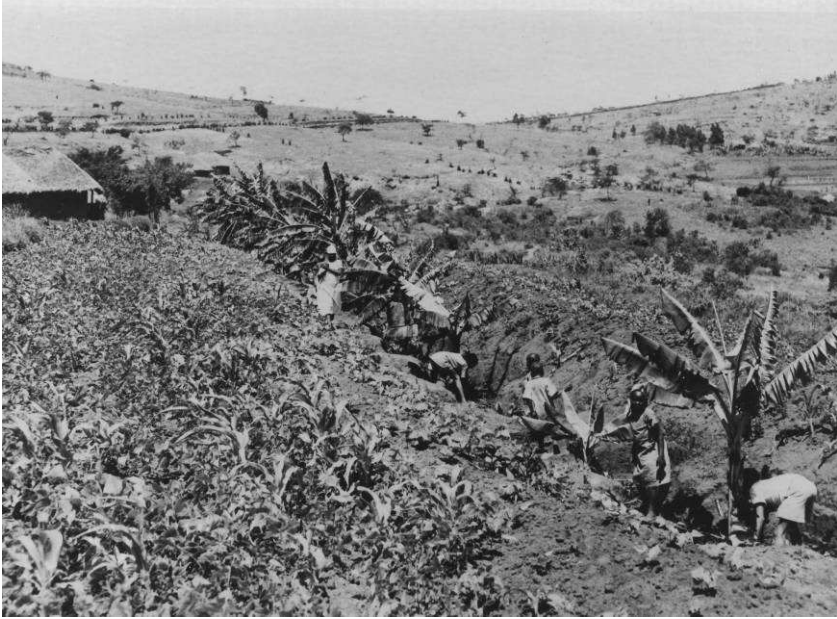
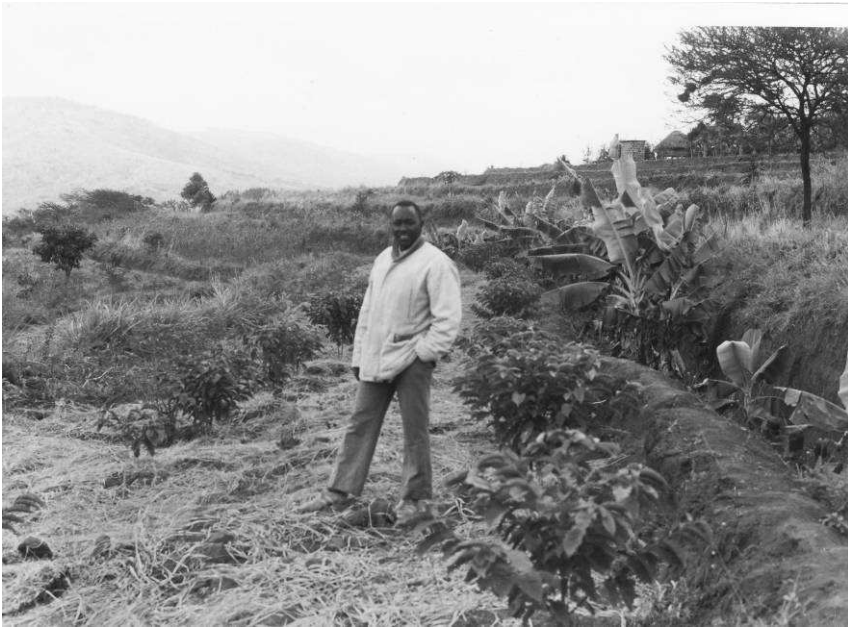
FIGURE 11.4. Banana trenches, (a) 1952 and (b) 1990. The 1952 caption notes how the trench prevents wash from the road and hill-side destroying the terraced arable. Pastor Mutua's banana trench in 1990 is also trapping water from a small road near the farm; water infiltrating out of it will feed his recently planted coffee, which he is experimenting with although this is AEZ 4. (Photos: Kenya, ALUS, 1953, Crown Copyright, reproduced with permission of the Central Office of Information and D. B. Thomas)

where water is within the reach of roots (see Figure 11.4). In 1981 (Ecosystems, 1982, Vol.1: 78) the average density of bananas in the District was $12/\text{km}^2$; the highest density was in Northern Division ($40/\text{km}^2$), but even in Makuani Division a density of $8/\text{km}^2$ was recorded.

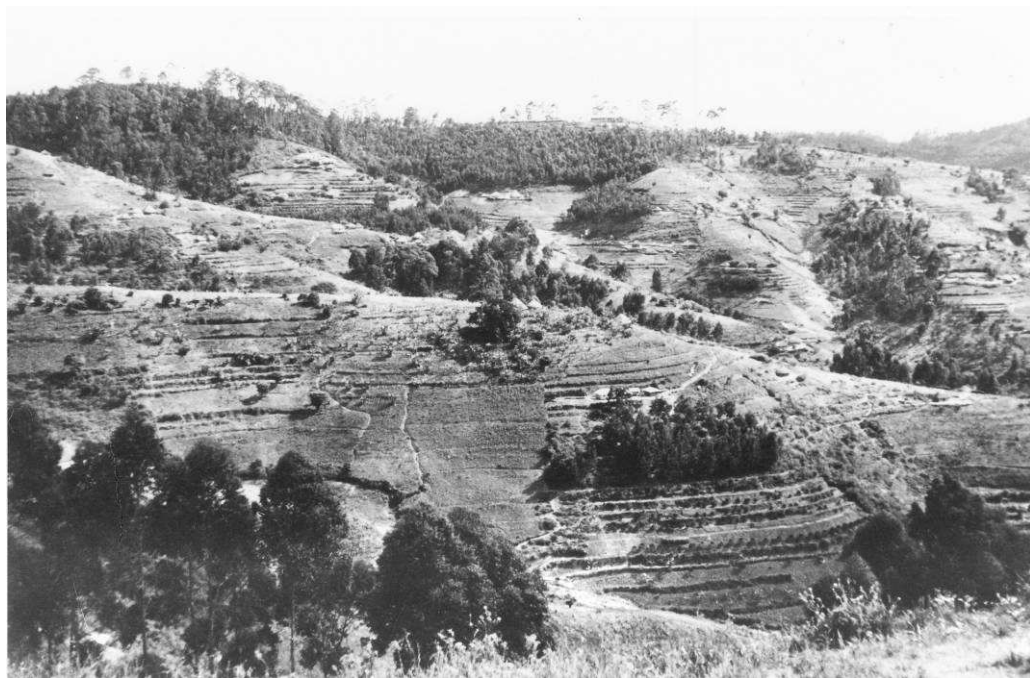
FIGURE 11.7. Terracing in Kilungu, 1964. Although this was taken to illustrate 'post World War II achievements in soil conservation', it clearly shows the decay of narrow-based terraces, and other areas where *fanya juu* have been installed. (Photo: F. N. Owako, 1969. Reproduced with permission)

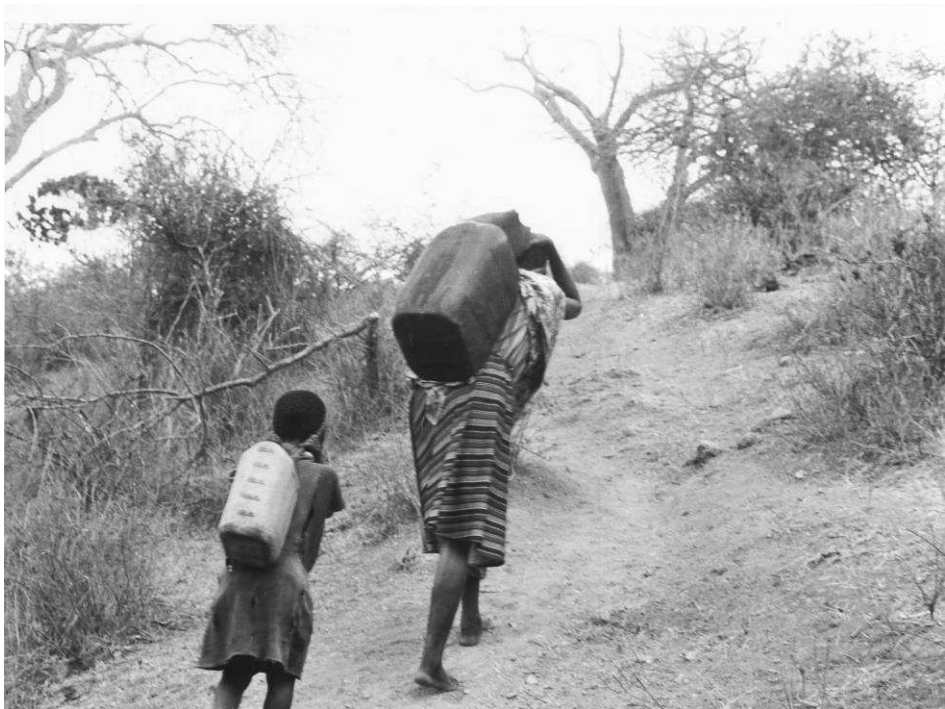
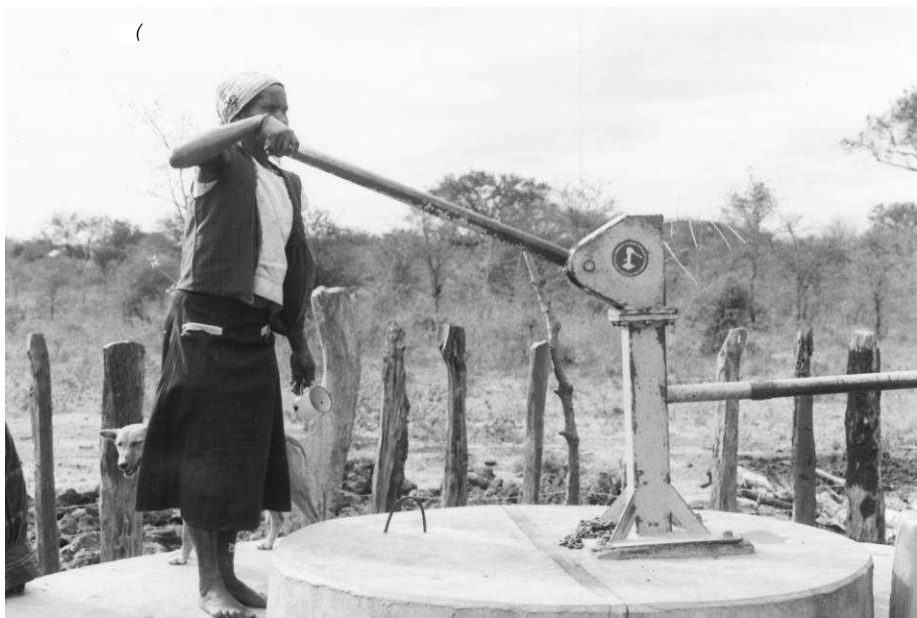
FIGURE 12.1. Carrying water home, near the Kambu river, AEZ 5, August 1990. (b) A hand pump supplied by the African Medical Research Foundation (AMREF) in Kibwezi Division, typical of NCO programmes. (Photos: D. B. Thomas, reproduced with permission)
