FIGURE 1.2. Kalama Hills from Kivandini, June—July (?) 1937. Map Sheet 162/2, GR 3104E, 98302N Brg. 145°. (Photo: KNA: R. O. Barnes, 1937, photo 1. Reproduced by permission of Kenya National Archives.)

FIGURE 1.3. Kalama Hills from Kivandini, September 1991. Map Sheet 162/2, GR 3104E, 98302 145°. (Photo: M. Mortimore)

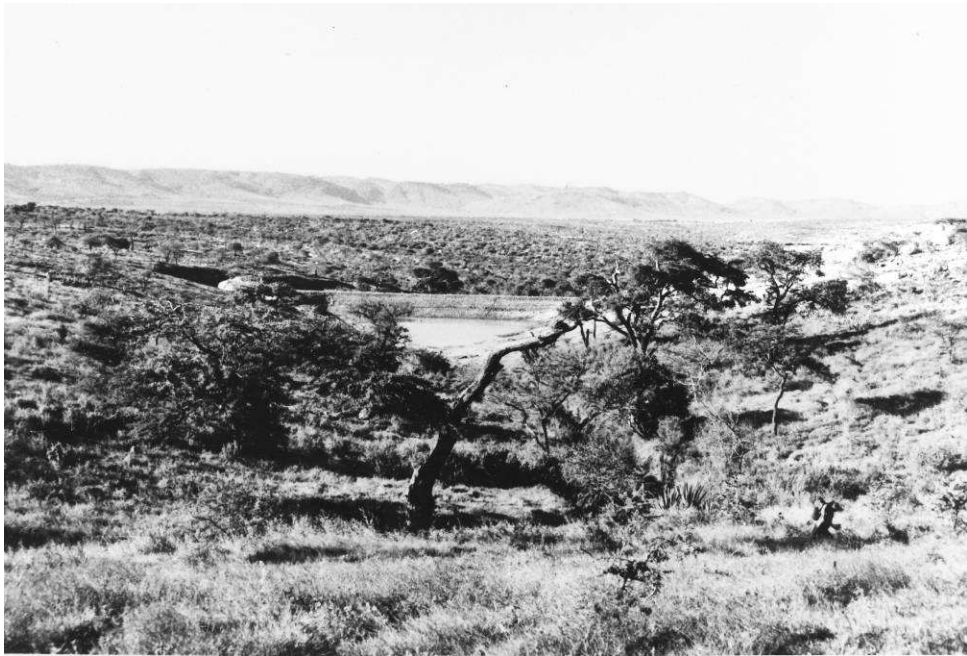
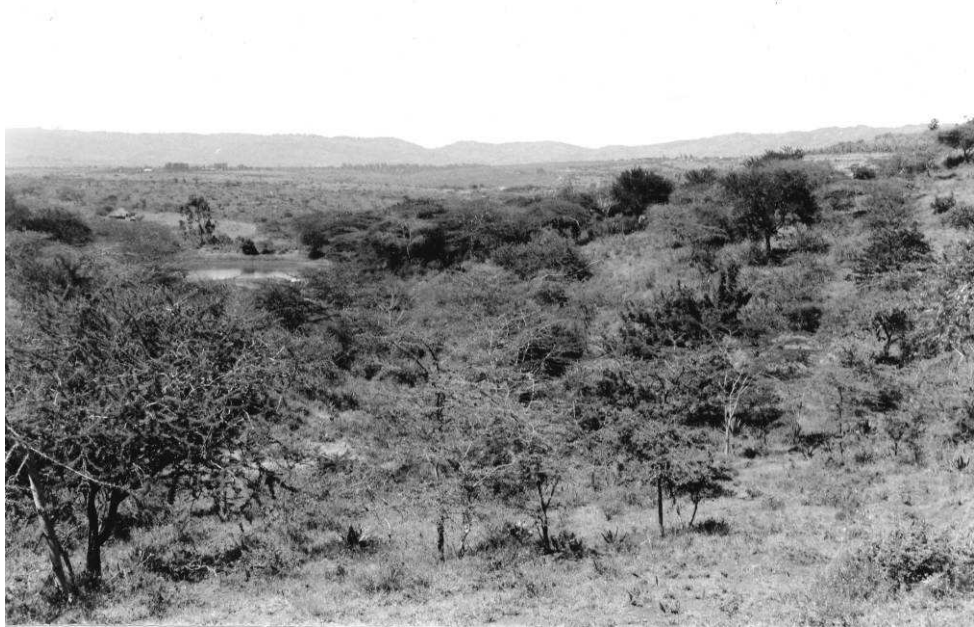
FIGURE 12.2. (a) A dam built by the mechanical unit of ALDEV, photographed in 1952. It also showed 'the extent to which the terraced badlands have recovered'. (Photo: Kenya, ALUS, 1953. Crown Copyright. Reproduced with permission of the Central Office of Information). (b) In 1990 this land was still used for grazing, with increased tree cover, and the dam was still in use. (Photo: M. Mortimore.)

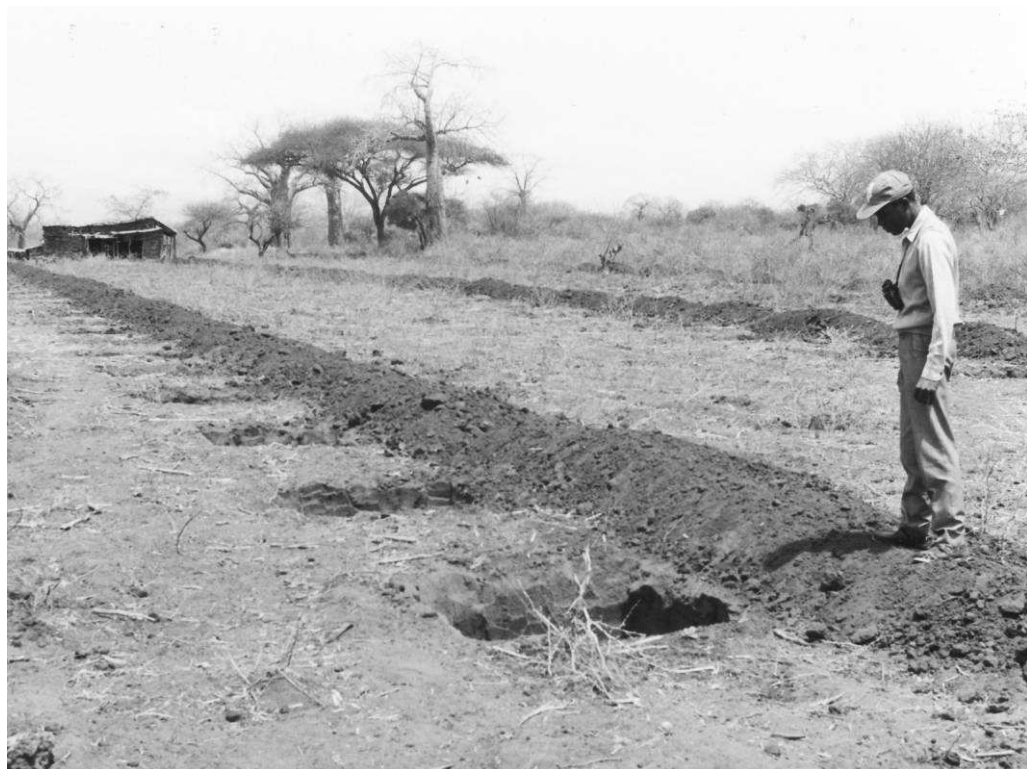
FIGURE 14.1. Hole digging for citrus in AEZ 5, Kamu, Ngwata Location, 1990. The soil is being used to form terraces to trap run-off. The holes look similar in size to those insisted on for coffee in AEZs 2 and 3 in the 1950s and demonstrate the way technologies travel and are adapted. (Photo: D. B. Thomas reproduced with permission)

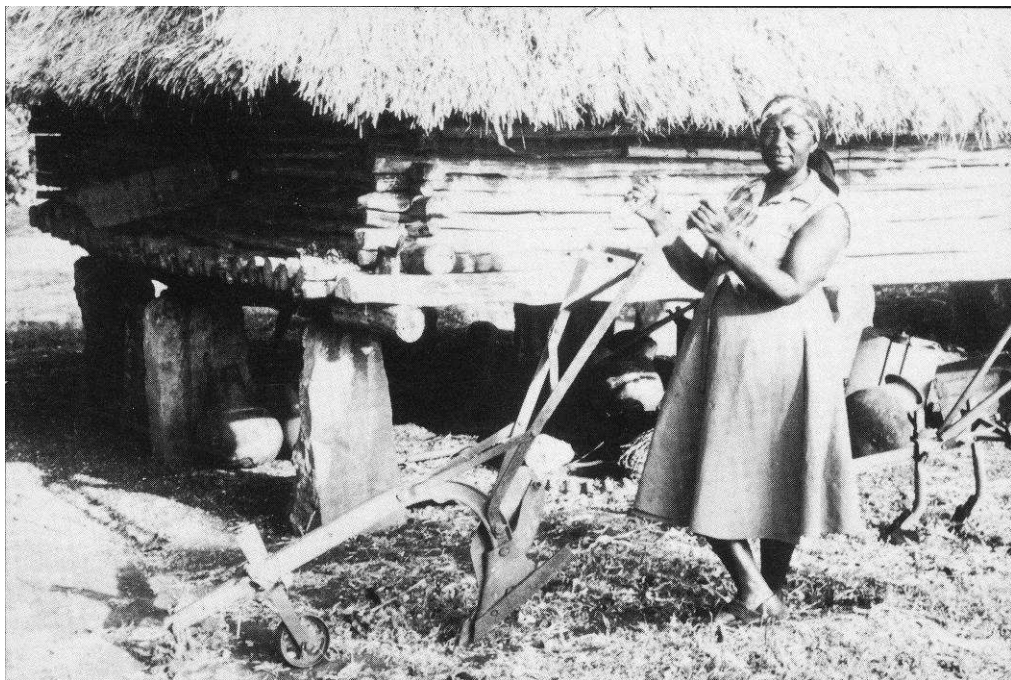
FIGURE 14.2. Alice Mulandi and her plough. She is a member of one of the composting groups in Makeveti. Her grain store illustrates one of the reasons why building timber is in demand. (Photo: M. Mortimore)

negligible. Several hundred units were left unsold, and most users preferred their old ploughs, finding the MIDP equipment too heavy for their draft oxen and much more expensive (ODI, 1982). There is no record of farmer participation in research and development. An evaluation report concluded that the problems of the mouldboard plough had been overestimated. The mouldboard plough, slightly modified and available in different sizes, is the one principally used in Machakos today.

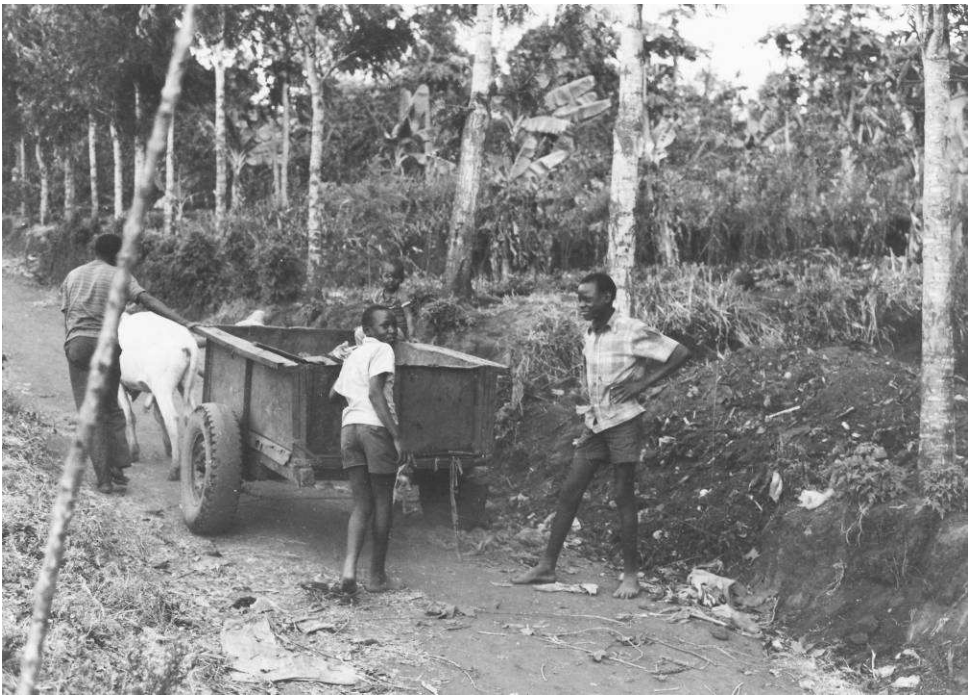
FIGURE 14.3. Boys transporting waste from Kangundo town to use as manure on the farm. (Photo: D. B. Thomas. Reproduced with permission)
